Manhole Inspection Summary

Manhole # S03YY1016MH

Location Address: **6019 HIGHAGTE RD**

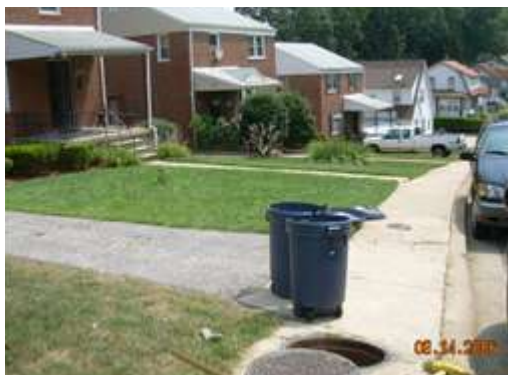
Location View

Comments **Cracks around manhole. Possible source of infiltration.**

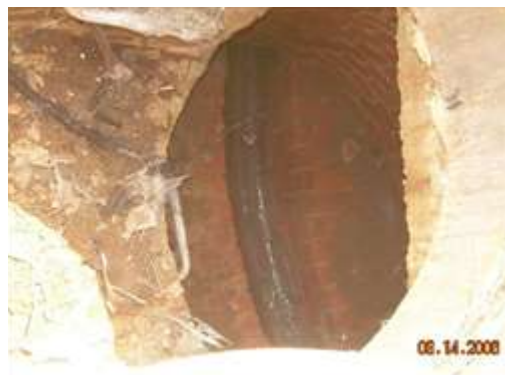
Top View

Condition: ☐ Sound ☐ Cracked ☐ Root Intrusion ☐ Deteriorated ☐ Leaks ☒ **Debris**

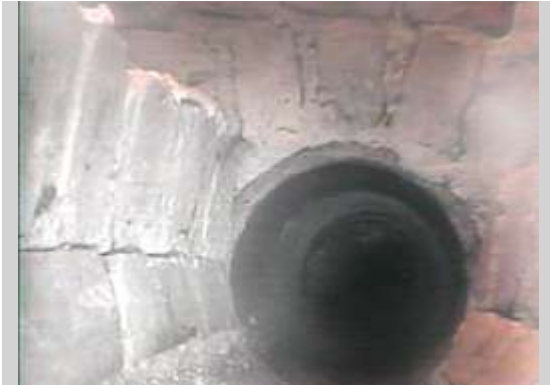
8 in. Circular Gravity Sewer Pipe Out @ 12 O'Clock

Infiltration: **Evidence** Pipe Seal Cond: **Unknown**

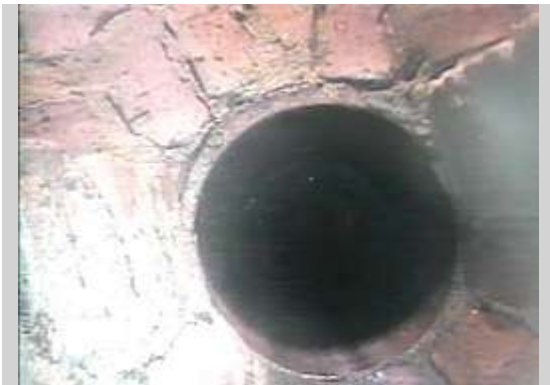
8 in. Circular Gravity Sewer Pipe In @ 5 O'Clock

Infiltration: **Evidence** Pipe Seal Cond: **Cracked**
